# **Response of Vegetation and Fish During an Experimental Drawdown In Three Pools, Upper Mississippi River**

**August 2000**

Joseph H. Wlosinski, James T. Rogala, Thomas W. Owens, Kenneth L. Dalrymple,  
David Busse, Claude N. Strauser, and Elmer Atwood

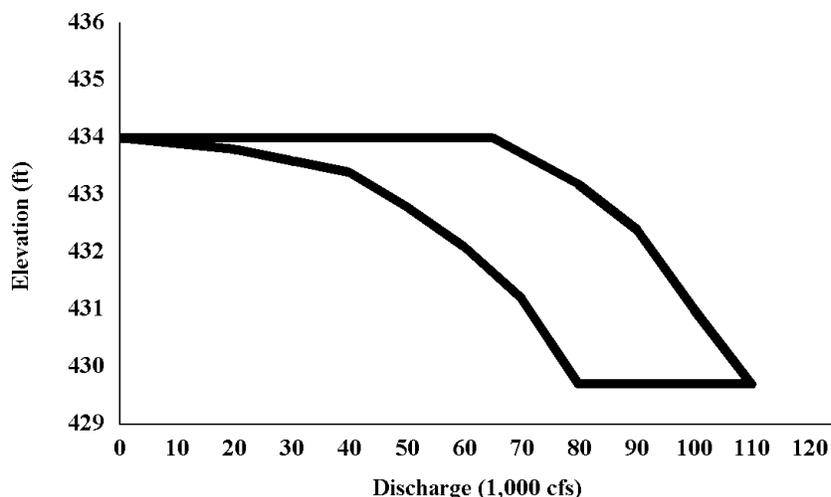
**Figure 2.** Water elevation relative to discharge according to the water-level management plan for Pool 25. Wlosinski (1996) includes information on how discharges were estimated.

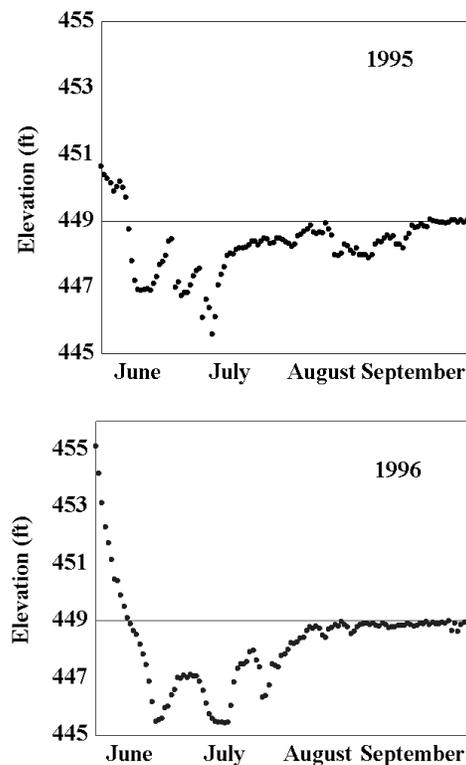
**Figure 3.** Measured water-level elevations (feet above sea level) immediately upriver of Lock and Dam 24 in 1995 and 1996.

Water levels during summers 1995 and 1996 are presented for Pools 24 and 25 and Melvin Price Pool in Figures 3, 4, and 5, respectively.

Figure 6 contains water levels in Pool 22 during 1995 for comparative purposes. The horizontal line in the figures represent the project pool elevation for the respective pools. Open river conditions existed in all four pools at the beginning of June, for both years, with the drawdown being initiated as soon as conditions allowed except for Pool 22. Drawdown amounts vary within and among pools as a function

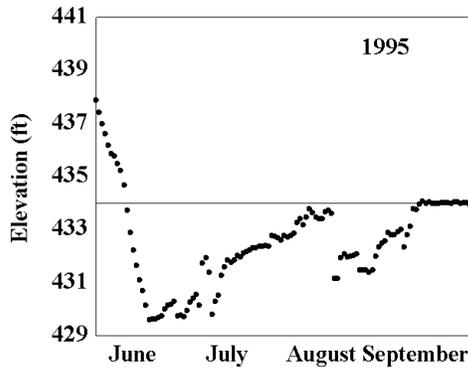
**Figure 4.** Measured water-level elevations (feet above sea level) immediately upriver of Lock and Dam 25 in 1995 and 1996.

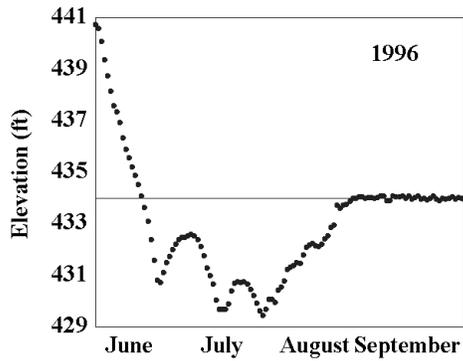
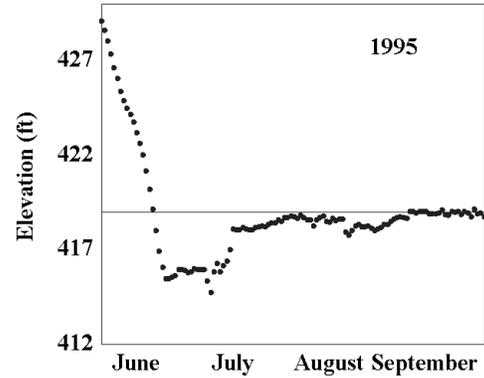
**Figure 5.** Measured water-level elevations (feet above sea level) immediately upriver of Melvin Price Locks and Dam in 1995 and 1996.

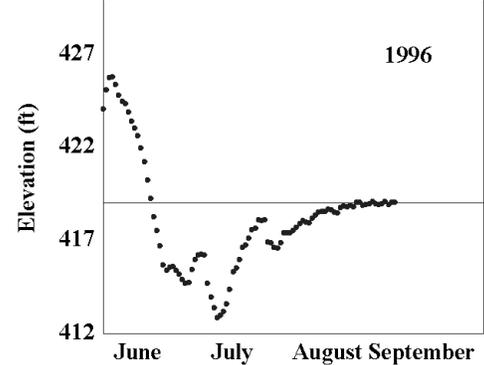
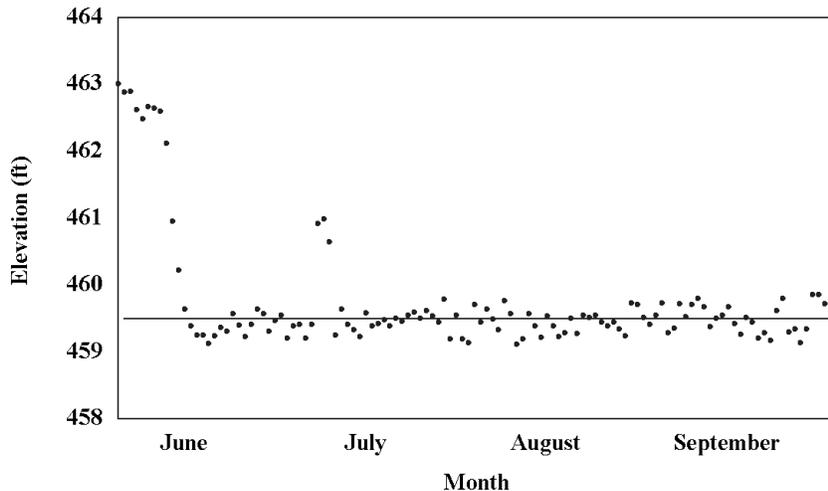
**Figure 6.** Measured water-level elevations (feet above sea level) immediately upriver of Lock and Dam 22 in 1995.

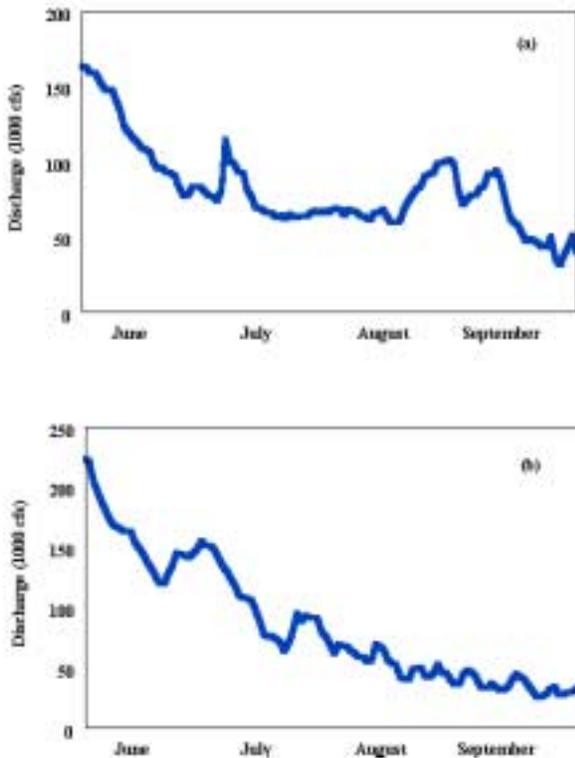
**Figure 7.** Estimated discharges at Keokuk, Iowa, in 1995 (a) and 1996 (b).

Discharge is also being presented for the same periods for Keokuk, Iowa (Figure 7), and Grafton, Illinois (Figure 8), for comparative purposes. These are the two closest gages where discharge is estimated by the U.S. Geological Survey. The gage at Keokuk is about 63 miles (101 km) upriver of Dam 22, and the gage at Grafton is in Melvin Price Pool about 17 (27 km) miles upriver of the dam.

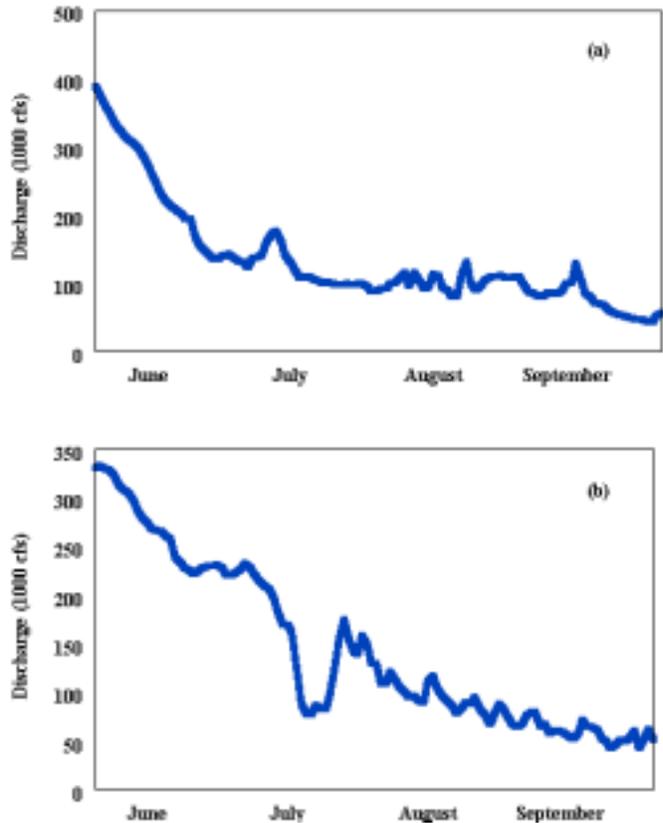
**Figure 8.** Estimated discharges at Grafton, Illinois, in 1995 (a) and 1996 (b).

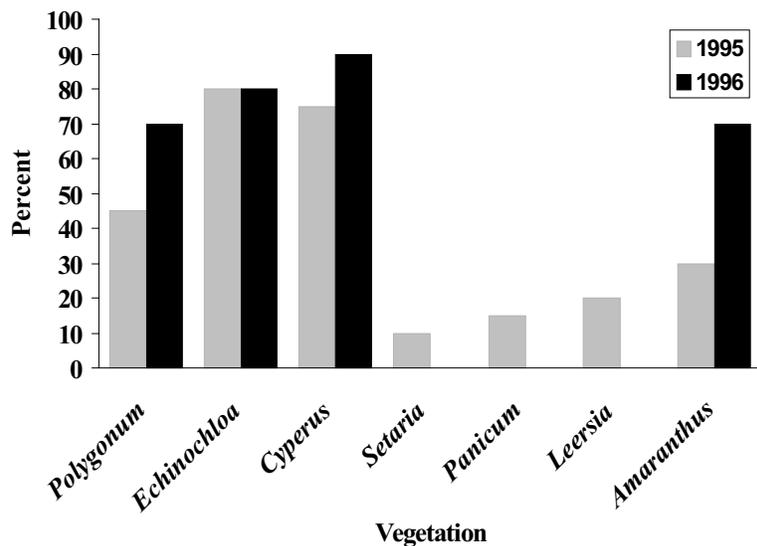
**Figure 9.** Frequency of occurrence of vegetation at all sampling sites in 1995.

Seven plant genera were identified in the 20 survey sites in 1995 (Figure 9): *Polygonum* spp., *Cyperus* spp., *Echinochloa* spp., *Amaranthus* spp., *Setaria* spp. (yellow foxtail or bristlegrass), *Panicum* spp., (panicum), and *Leersia* (rice cutgrass). The above species were also present during the 1996 survey except for *Setaria* and *Panicum*, with the dominant plants being found at a greater percentage

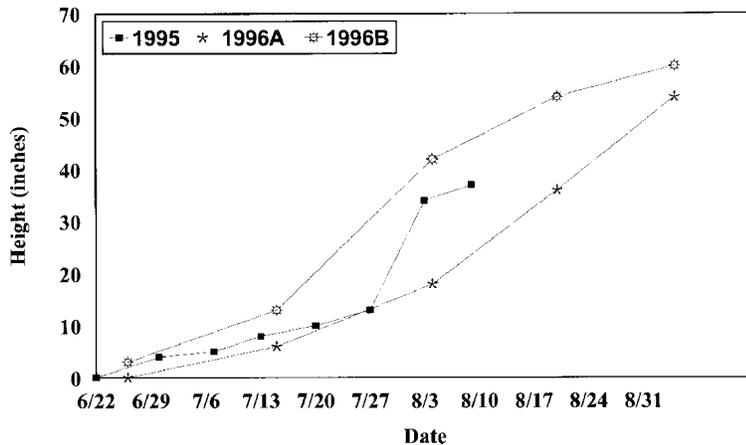
**Figure 10.** Average height of *Echinochloa* spp. (millet) at all sampling sites. Heights were measured for plants that germinated at two different times (1996A and 1996B).

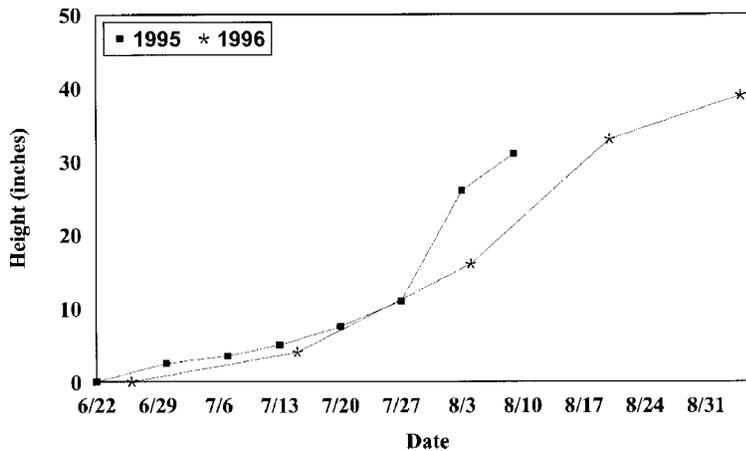
**Figure 11.** Average height of *Cyprus* spp. (chufa) at all sampling sites.

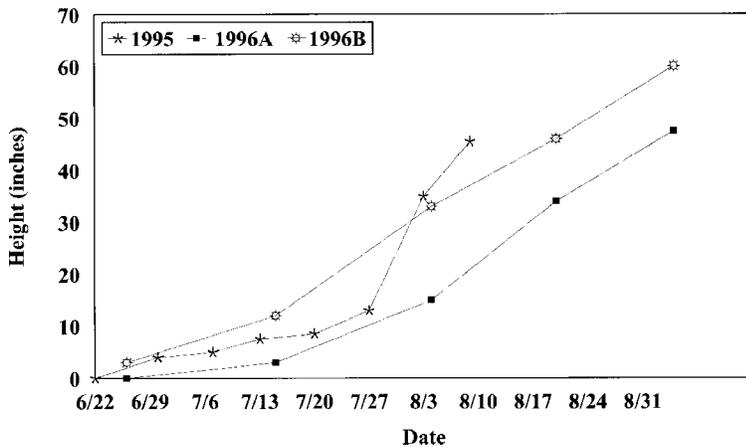
**Figure 12.** Average height of *Polygonum* spp. (smartweed) at all sampling sites. Heights were measured for plants that germinated at two different times (1996A and 1996B).

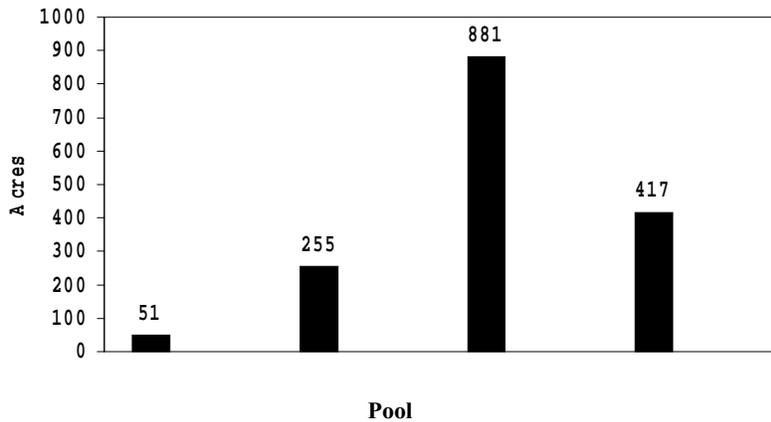
**Figure 13.** Acres of vegetation near the waterline in 1995 estimated from aerial photography.

Between 255 and 881 acres (91 and 357 ha) of plants were measured near the water line in Pools 24 and 25 and Melvin Price Pool, compared to just 51 acres (20.6 ha) in Pool 22. Less than 60 acres (24 ha) of plants were found in all four pools in 1989 when water levels were held on the high side of the operating band. However, we cannot be sure that the difference in 1995, between Pool 22 and the other pools, is attributable solely to water levels in Pool 22 not being dropped as in the three other pools. Other factors, such as bottom geometry and sediment types, may have also played a role in the acreage figures among pools. In addition, estimates of vegetated areas may be low because narrow

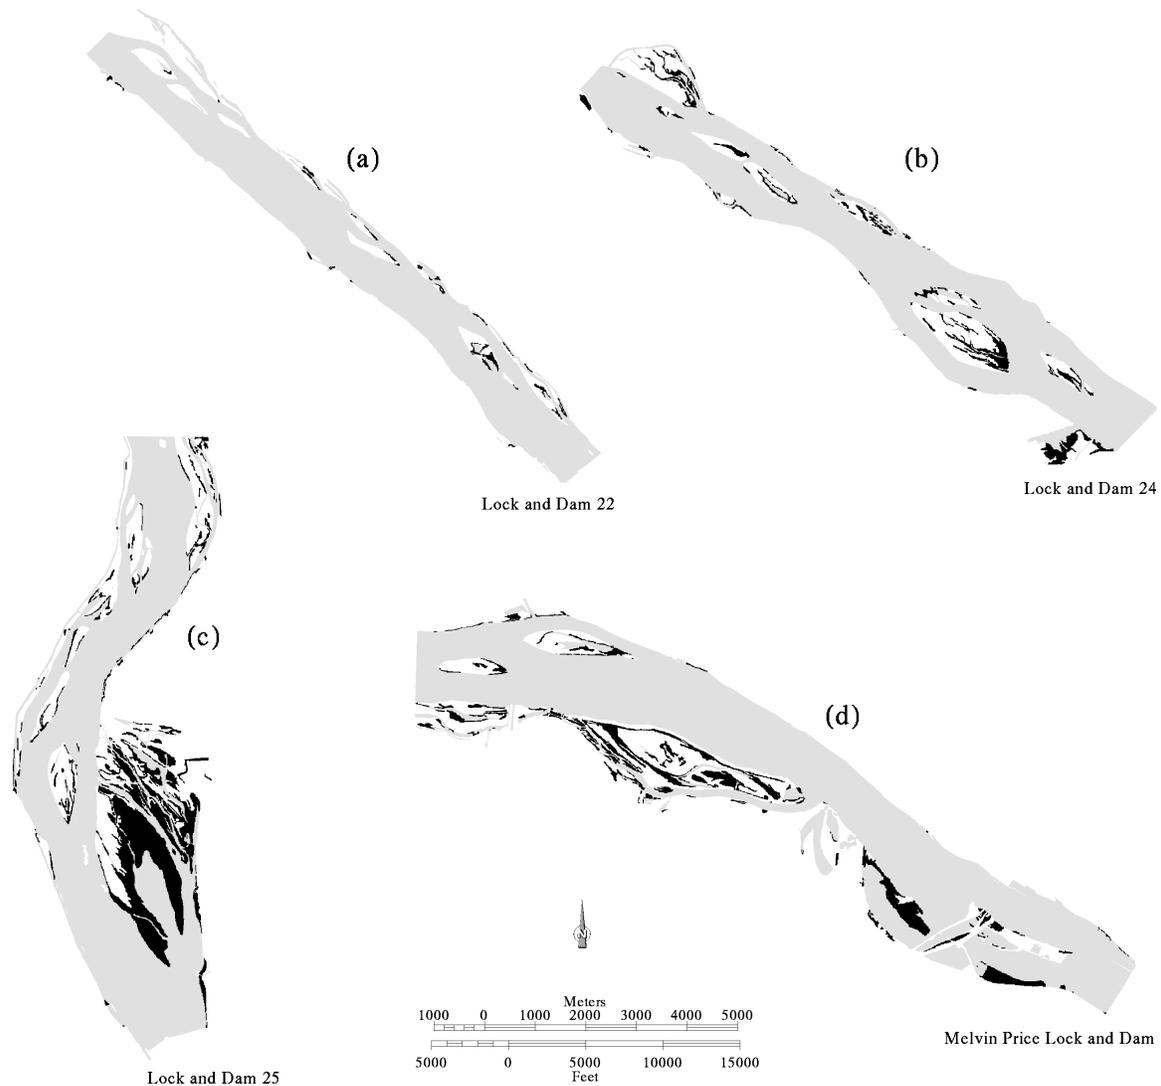
**Figure 14.** Areas of vegetation (*black*) in Pools 22 (a), 24 (b), and 25 (c), and Melvin Price Pool (d) thought to be caused by a drop in water levels.

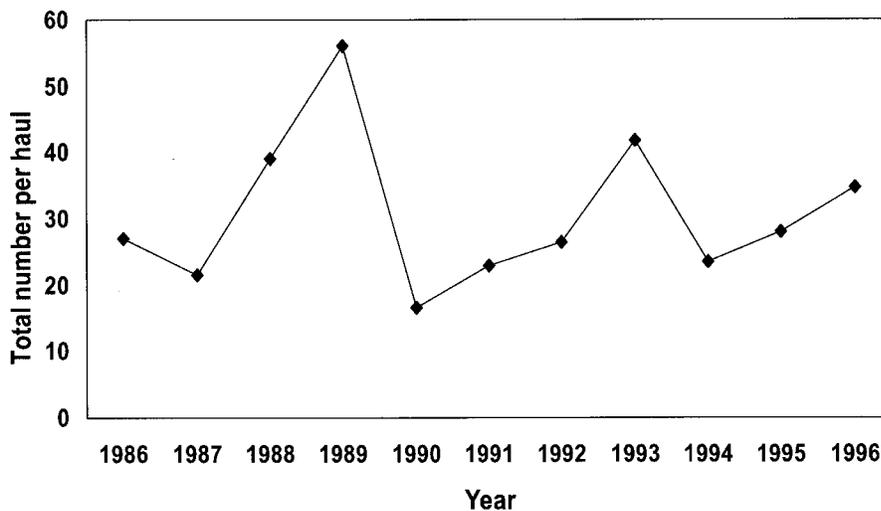
**Figure 15.** Mean total numbers of fish (all species) per seine haul in Pool 24.

The number of fish per haul is shown in Figures 15 through 17 for Pools 24 through 26, respectively. The average number of fish per haul between 1986 and 1993 was 27.6 in all three pools combined, as compared with an average of 29.2 fish between 1994 and 1996. The total number of fish collected per haul for the upriver and downriver

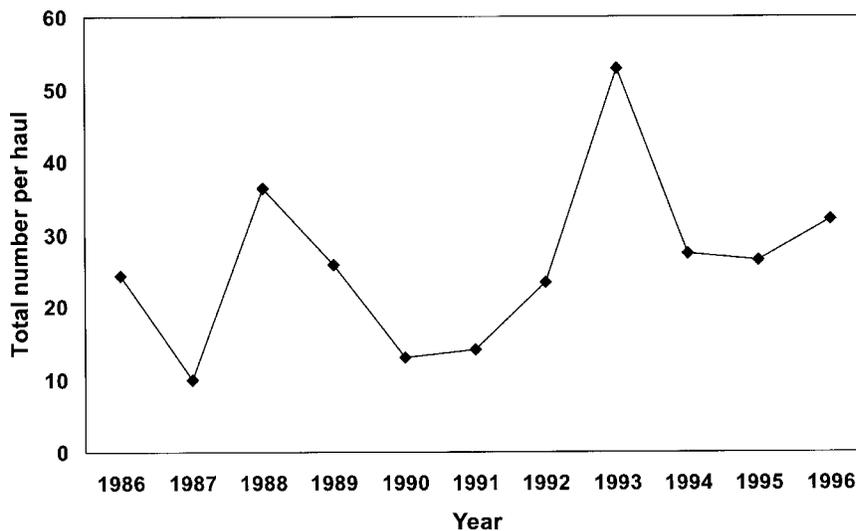
**Figure 16.** Mean total numbers of fish (all species) per seine haul in Pool 25.

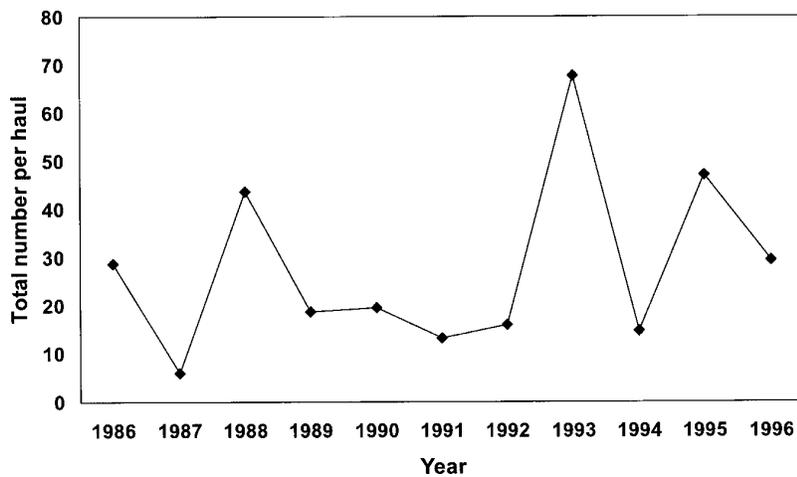
Figure 17. Mean total numbers of fish (all species) per seine haul in Pool 26.

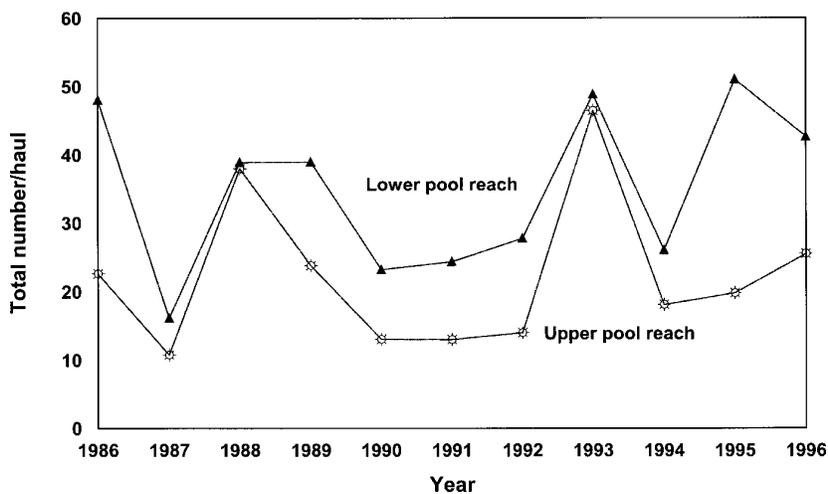
Figure 18. Mean total numbers of fish (all species) per seine haul in the upriver and down river portions of Pools 24, 25, and 26.

portions of the pools is shown in Figure 18. In the downriver portion of the three pools, the average number of fish per haul between 1986 and 1993 was 32.9, as compared with an average of 40.0 fish between 1994 and 1996. The averages in the upriver portion of the pools were nearly equal between the two periods; 22.6 between 1986 and 1993 versus 21.0 between 1994 and 1996.

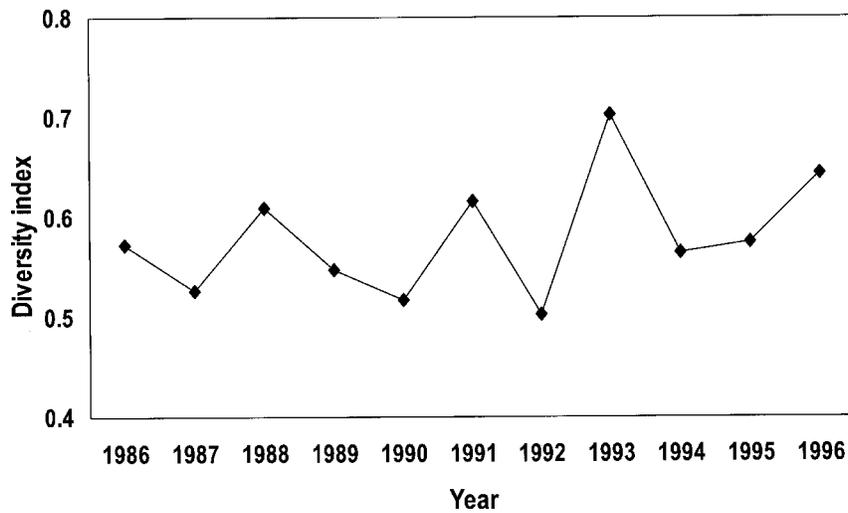
Figure 19. Simpson's Diversity Index for fishes sampled by seining in Pool 24.

Similar results were found for Simpson's Diversity Index. The average index was 0.57 for all three pools when water levels were held on the high side of the operating band, compared with an index of 0.58 between 1994 and 1996. The index for Pools 24 through 26 are shown in Figures 19 through 21, respectively.

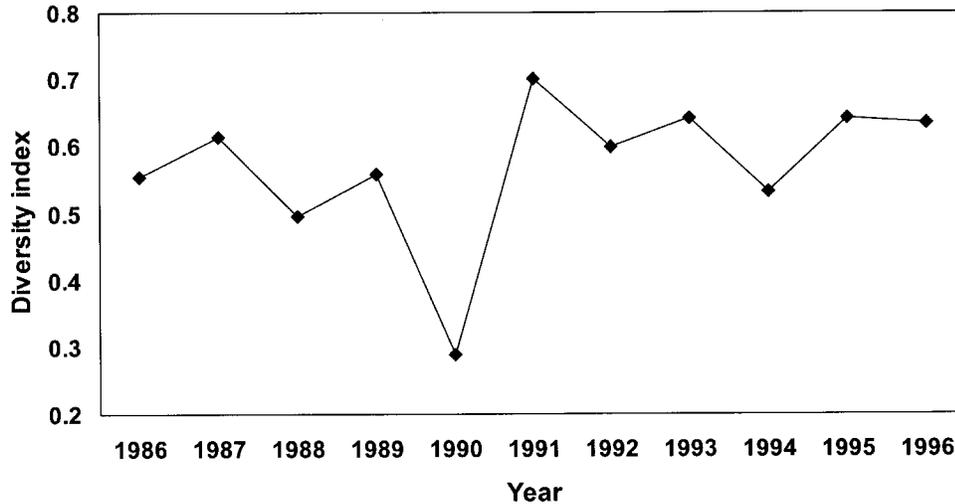
Figure 20. Simpson's Diversity Index for fishes sampled by seining in Pool 25.

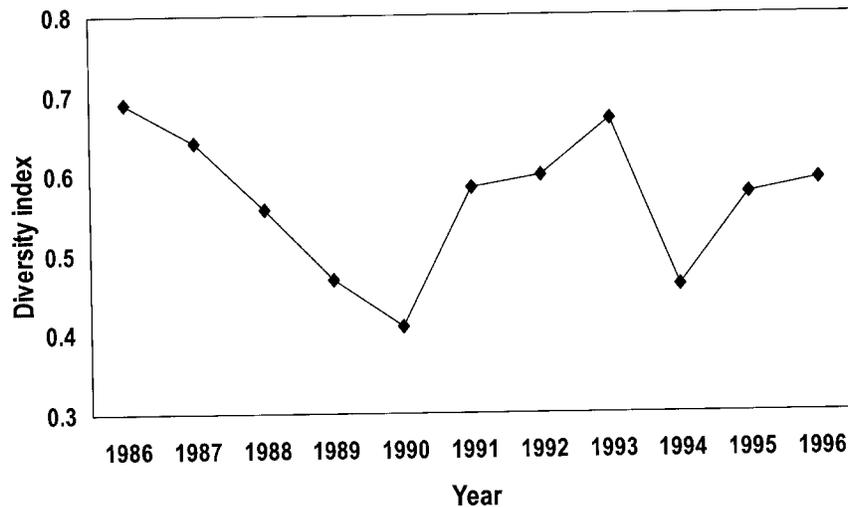
Figure 21. Simpson's Diversity Index for fishes sampled by seining in Pool 26.

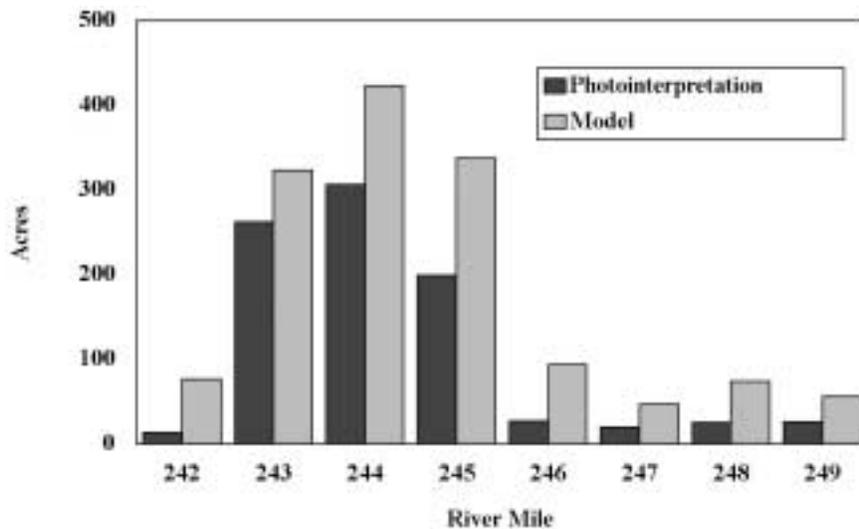
**Figure 22.** A comparison of acreage of dewatered areas predicted by the model to acreage of vegetation

estimated from photointerpretation (Figure 22). The greatest effect was near Batchtown at river miles (km) 243 (391.0) through 245 (394.2). However, although predicted and observed areas were usually in the same general areas, they were not necessarily the same exact areas (Figure 23). About 492 acres (199 ha) predicted to be dewatered had vegetation. Another 555 acres (225 ha) predicted to be dewatered did not have vegetation, according to the photointerpreter. In addition, 387 acres (157 ha) had vegetation observed in areas not predicted to be dewatered by the model.

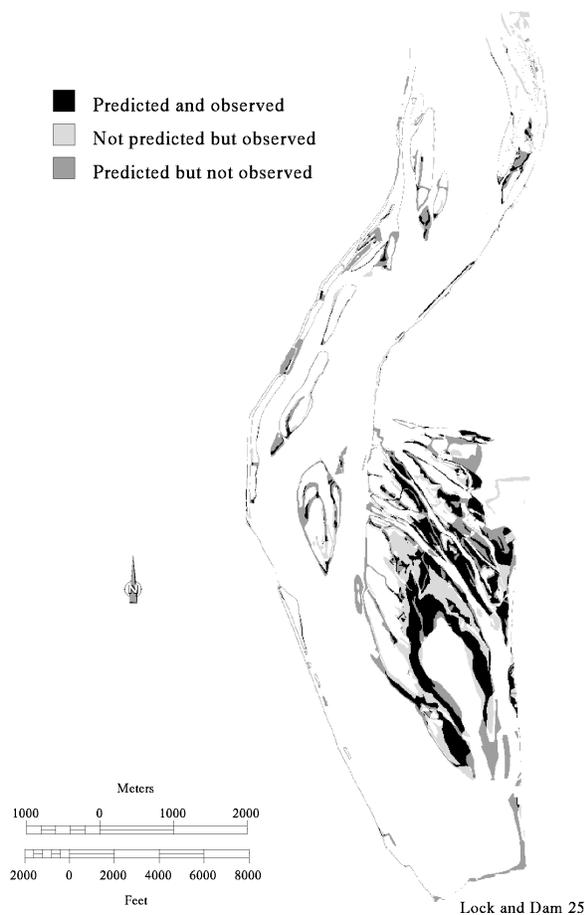
**Figure 23.** A map of dewatered areas as predicted by the model in comparison with areas with vegetation estimated from photointerpretation in the lower stretch of Pool 25.
